## Thurston Groves HOA Monthly Waterway Inspection Report

**Reason for Inspection:** Routine Scheduled - Monthly

**Inspection Date:** 5/24/2018

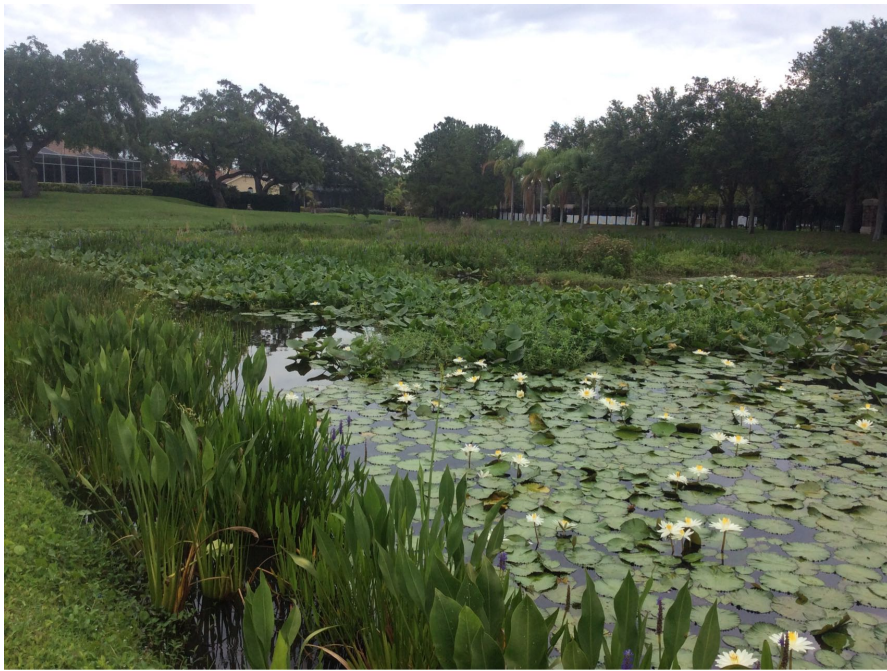
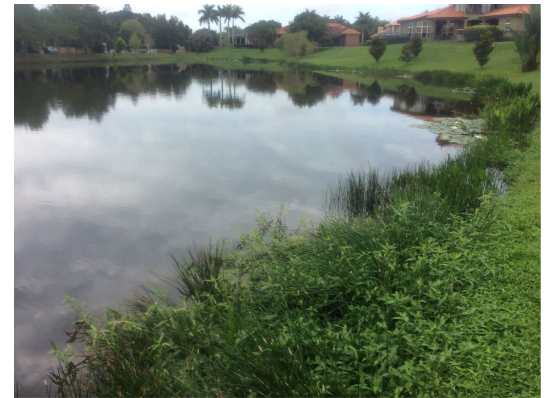
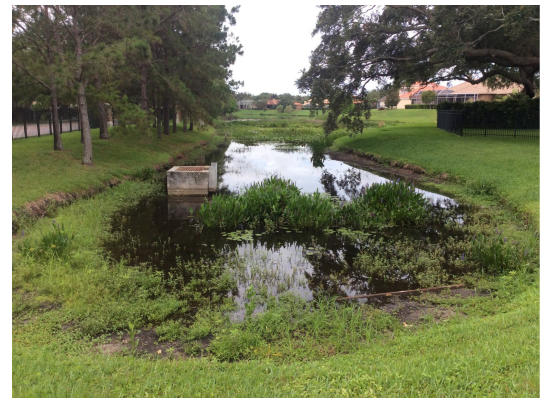
Site: 1

**Comments:** Normal growth observed

Throughout the May Inspection of the waterway at Thurston Groves, it was observed that new growth undesired vegetation was present within the beneficial plants along the perimeter of the site, as well as within the littoral shelf and upon the exposed banks of the site.

- Carefully spot spray the undesired growth of Alligator Weed, Primrose, and Torpedo Grass along the perimeter of the site, within the littoral shelf, and on the exposed banks of the site.
- Continue to monitor for regrowth of submersed weeds and algae, performing additional treatments as observed to maintain current conditions.
- Closely monitor the water level and water clarity as more frequent precipitation events are anticipated.
- Clear the control structure of flow-restricting materials.
- Monitor the burrowing behavior of the Plecostomus populations.
- Continue to foster the growth and establishment of Florida Native Beneficial Plants.
